# ADRE® for Windows saves a generator

*Proximity probes installed for more accurate data*

**by Mogens Greve**  
*Engineer B.S.C.M.E.  
Asnæs Power Station  
Denmark*

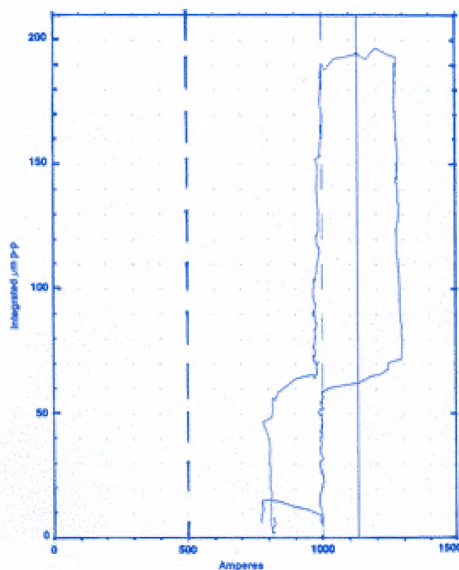
Figure 2:

We increased rotor exciter current from 800 to 1300 amperes, and after approximately 30 minutes, we saw a corresponding increase in 1X vibration with a constant phase angle (Figures 2 and 3). 1X vibration was dominant in Unit No. 1, especially on its generator bearings, Bearings 4 and 5. From this, we concluded that the high vibration was originating in the generator.

Exciter current versus Bearing 4 vertical velocity transducer vibration. Approximately 30 minutes after exciter current is increased from 800 to 1300 amperes, vibration increases.

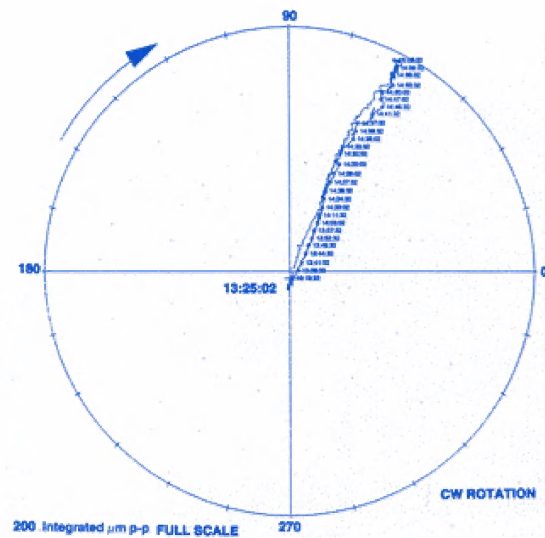
Figure 3:

Same data as Figure 2. As exciter current is increased from 800 to 1300 amperes, vibration at Bearing 4 increases with no change in phase angle.

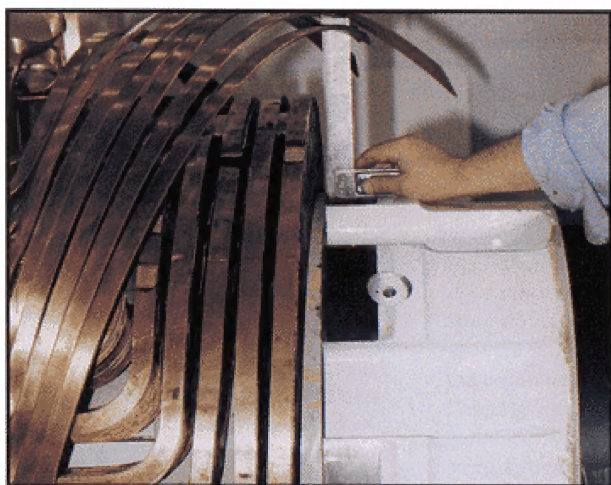
When we inspected the generator rotor, we saw that the generator windings were displaced axially by approximately 10 mm (394 mils) (Figure 5). The winding coils at one pole were pressing toward the retaining ring backplate, yielding unsymmetrical axial forces that preloaded and bent the rotor body, causing the increased 1X vibration. Further axial displacement could have led to a winding short circuit, as two of the windings were close to each other. This could have caused a more severe generator failure.

Figure 5:  
Disassembled generator, viewed from non-driven end. The winding coils are pulled toward the driven end. The retaining ring has been pulled back to reveal the windings. The top winding is the damping coil, shown partially disassembled.

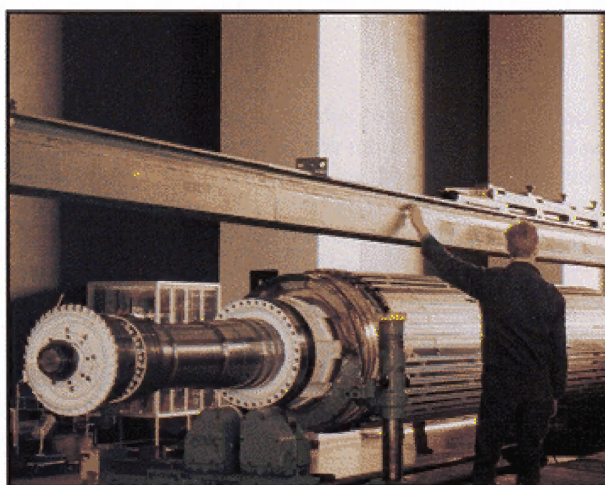
Figure 6:  
Generator rotor with dismantled retaining rings.

The rotor is currently under repair at Asnæs Power Station (Figure 6). Three OEM specialists and 18 Asnæs Power

Station employees are working in three shifts dismantling, straightening and reinstalling 12 of the 16 winding coils. We are modifying the bearing housing to reduce its structural resonance. **We also decided that we need better vibration information than can be provided by seismic, housing-mounted probes. On machines with fluid-film bearings, much of the energy generated by machine malfunctions is not transmitted to housing-mounted transducers. Proximity probes that directly observe the rotor provide much better diagnostic information. Therefore, in addition to seismic probes, we are installing XY proximity probes on each bearing.**

After repair, the rotor will be transported to the manufacturer for balancing. Asnæs Power Station staff will field-balance the unit using Bently Nevada's ADRE® for Windows Software, 208 DAIU and Multiplane Balancing Software.
